Technical **Report**

Title: Condition Assessment and Remaining Service Life
Analysis of Asbestos Cement Water Mains - Phase 4

Client: [CLIENT]

Date: February 3, 2020

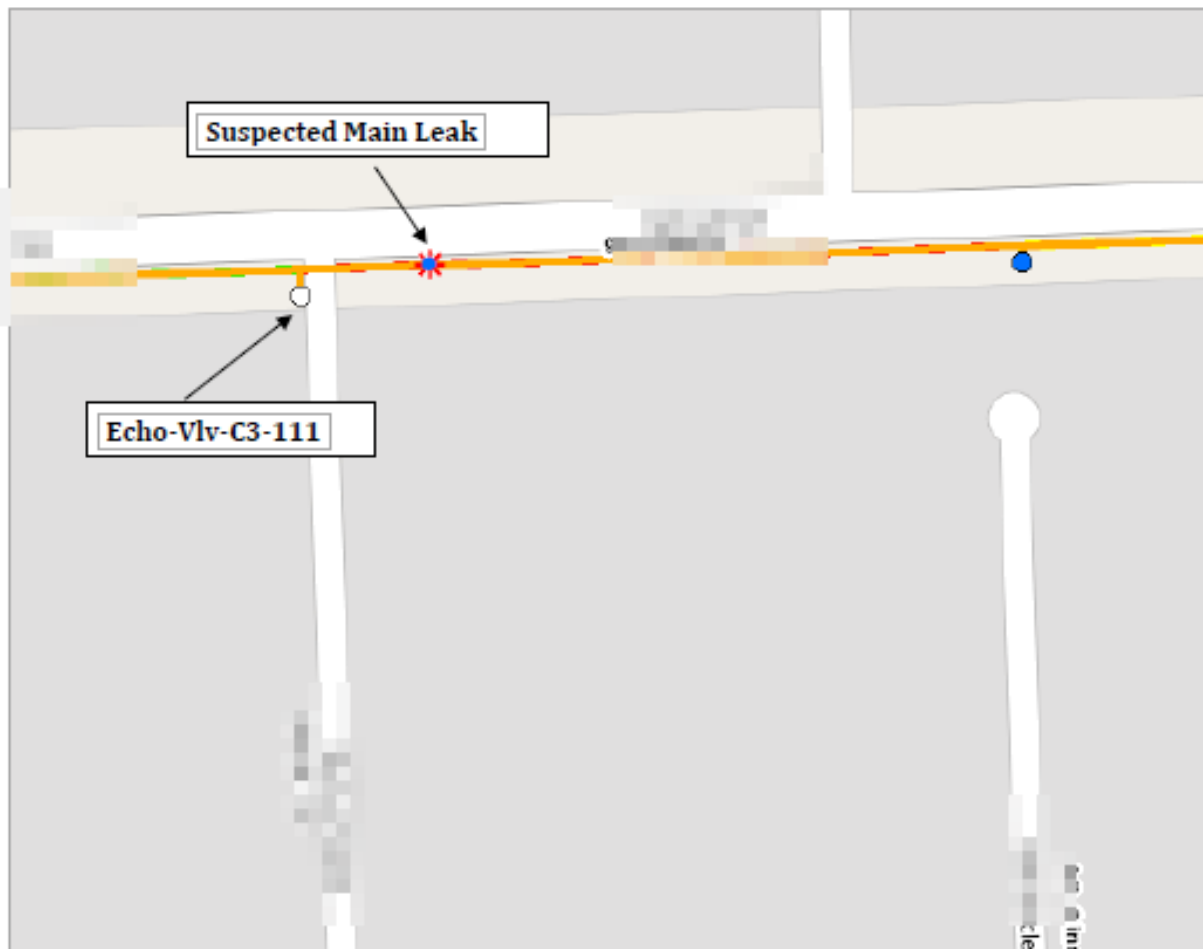
Figure 2: Suspected Leak within Segment 24 on [STREET]

Echologics correlated a noise source within segment 24 on three different occasions. This noise source was 82 feet east of the Echo-Vlv-C3-111 on [LOCATION]. Echologics field crew attempted to ground sound and look for evidence of water or wet ground at the location. Initially no leak noise was audible at the suspected leak location and neither any evidence of water was found.

Echologics field crew returned for additional tests and identified the same noise source at this location on two different occasions. The noise was also confirmed via ground sounding at the valve on nearby Walnut Street. Therefore, Echologics suspects this noise source to be a small main leak and recommends that it be further investigated. If confirmed as a leak, according to the AWWA M36 Water Audit and Loss Control Program, Echologics conservatively estimated a leakage rate of 29.3 GPM with a measured operating pressure of 82 psi. Figure 2 shows the location of the suspected leak within the network.

- C. One suspected leak was identified within Segment 24 on Heil Avenue. This should be further investigated to verify the presence of a leak
- D. 3 segments (segment 37, 38 and 64) did not yield results due to presence of suspected PVC or plastic pipe repairs in them

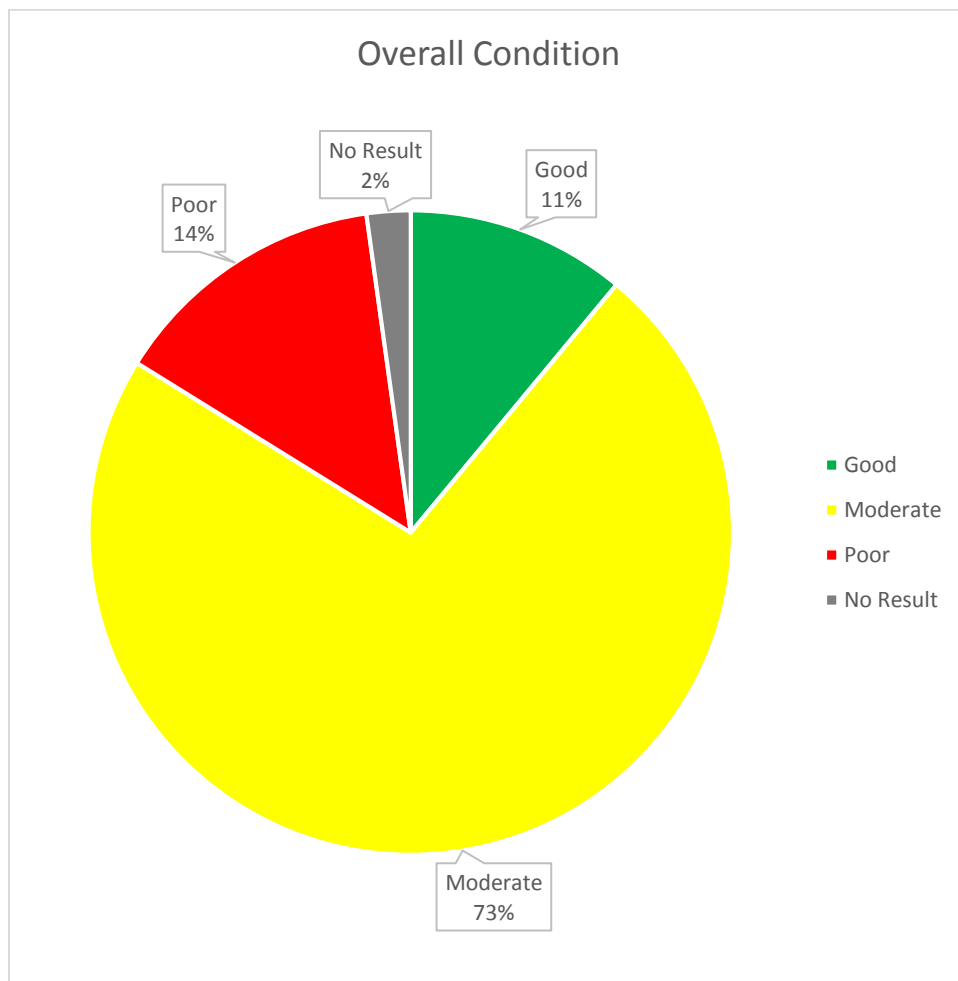
Figure 3: Overall Condition of Scope by Segment (%)

Observation of the entire data set of the 136 segments tested shows that the majority of segments appeared to be in moderate condition with wall thickness losses between 10% and 30%. There were also 19 segments (14%) that appeared to be poor condition. These segments are expected to have experienced significant degradation and loss of structural thickness. These segments should be prioritized while making rehabilitation or replacement decision making.

There were also 3 segments (segments 37, 38 and 64) that provided no result (“NR”) either due to inadequate correlation or very slow acoustic velocities. Both these phenomenon are associated with the presence of PVC or other plastic material within these segments. Echologics suspects there are PVC materials in these segments.

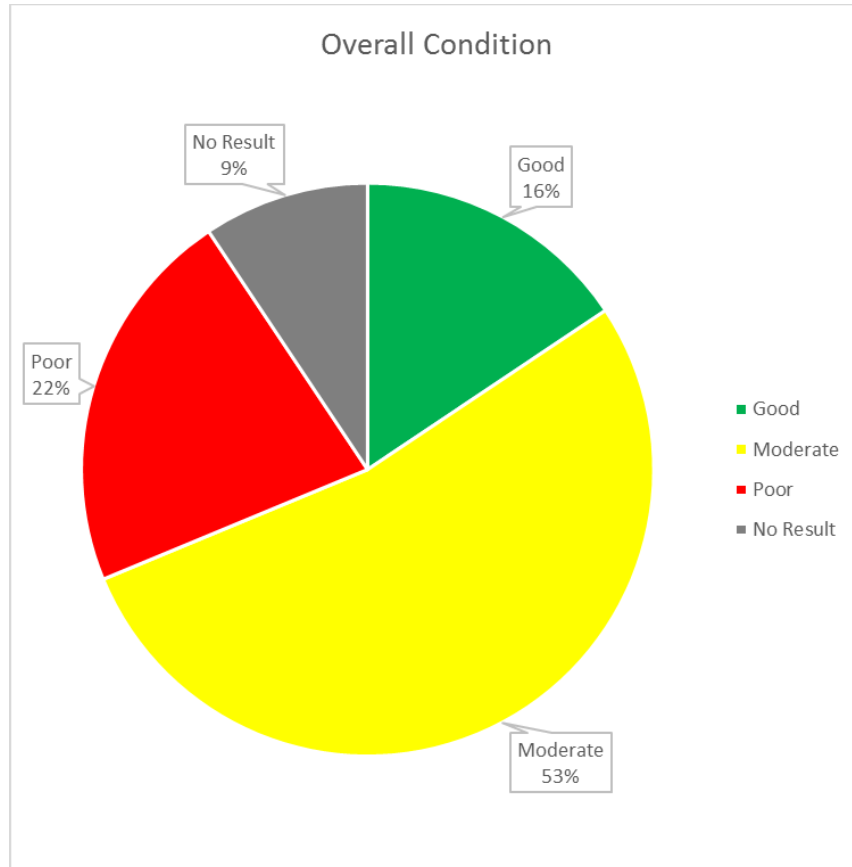
Figure 4: Overall Condition of Site 1

There were 32 segments tested in Site 1 on [STREET] This site contained 10,855 feet of 8-inch asbestos cement pipes, the majority of which appeared to be moderate condition.

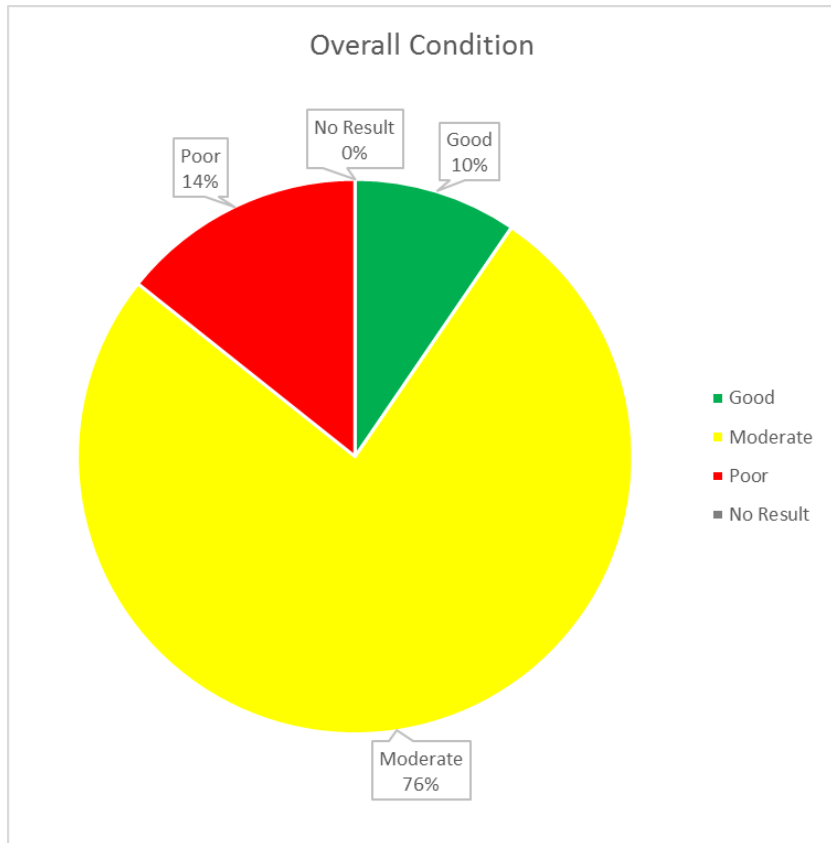
Figure 5: Overall Condition of Site 2

There were 21 segments tested in Site 2 on [STREET]. This site contained 7,929 feet of 8-inch, 12-inch and 16-inch asbestos cement pipes, the majority of which appeared to be moderate condition.

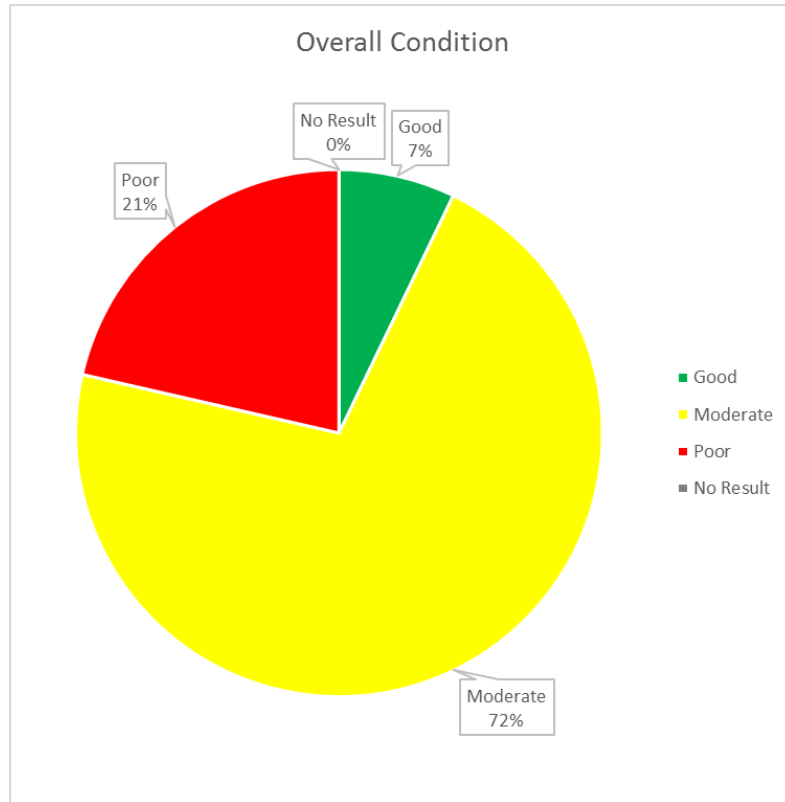
Figure 6: Overall Condition of Site 3

There were 14 segments tested in Site 3 on [STREET]. This site contained 5,202 feet of 8-inch, asbestos cement pipes, the majority of which appeared to be moderate condition.

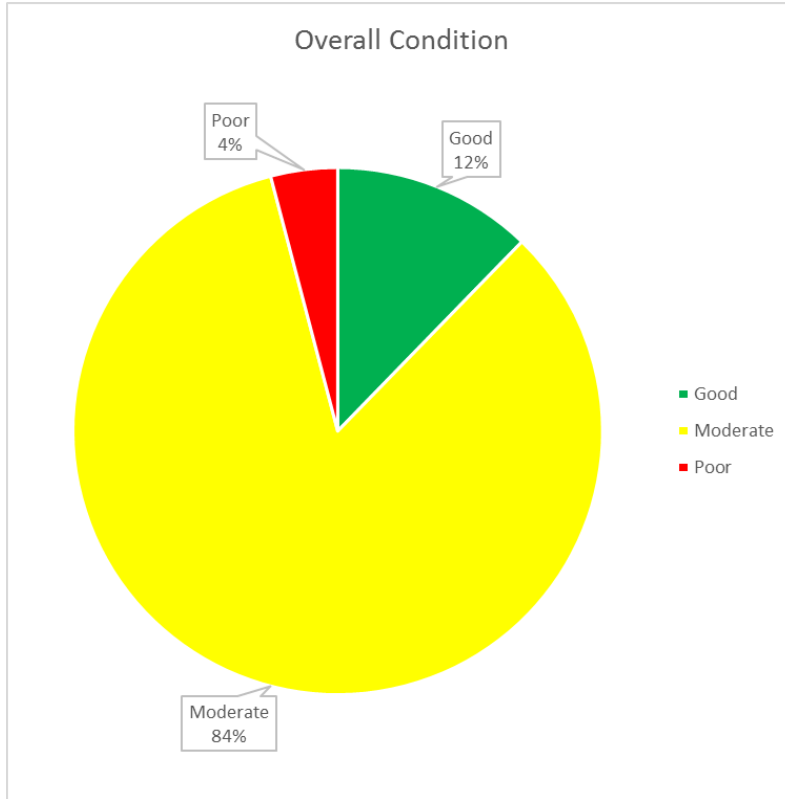
Figure 7: Overall Condition of Site 4

There were 49 segments tested in Site 4. These segments were located on several streets containing 19,919 feet of 8-inch and 12-inch asbestos cement pipes, the majority of which appeared to be moderate condition.

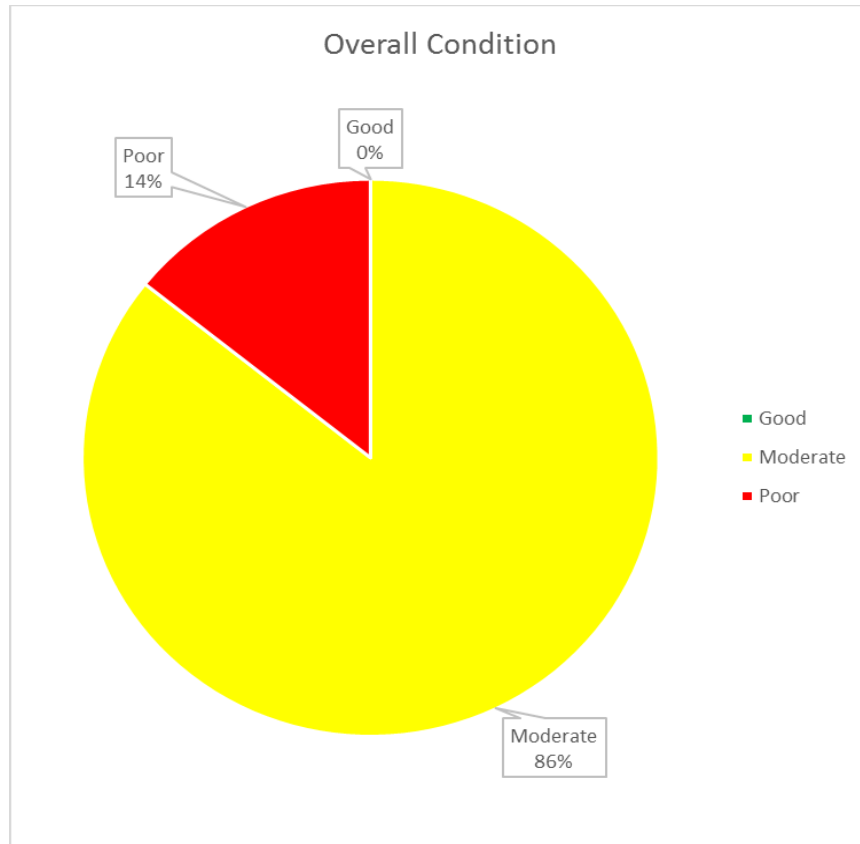
Figure 8: Overall Condition of Site 5

There were 49 segments tested in Site 4. These segments were located on several streets containing 19,919 feet of 8-inch and 12-inch asbestos cement pipes, the majority of which appeared to be moderate condition with the remaining in poor condition.

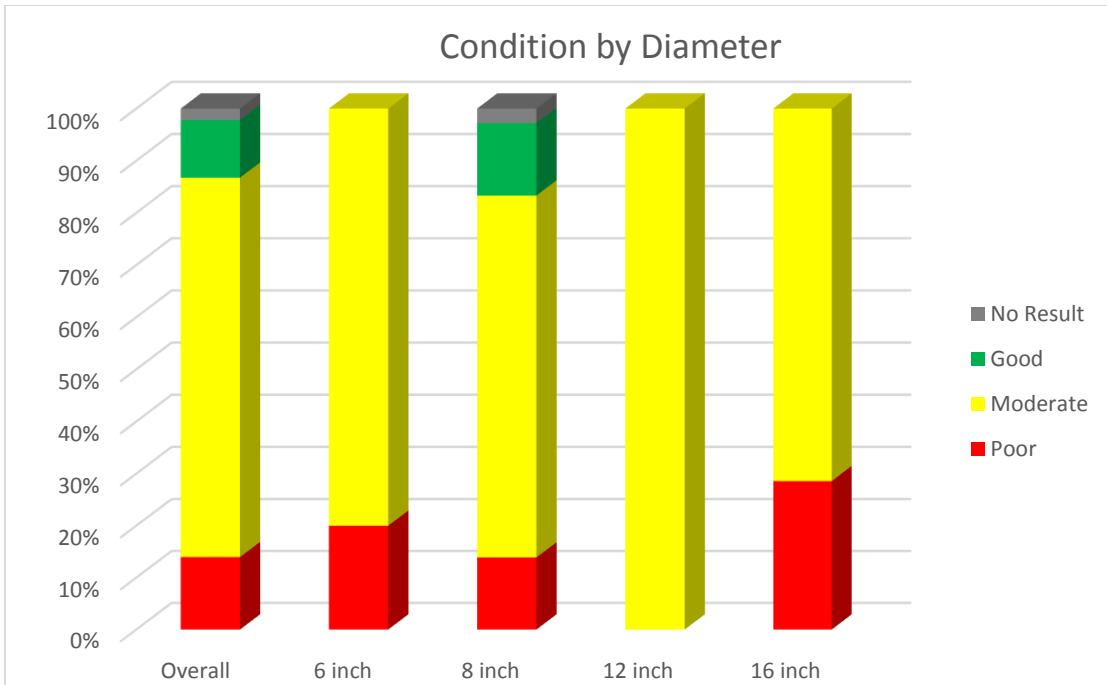
Figure 9: Distribution of Condition for Different Diameter

Figure 9 shows the distribution of the ePulse[®] condition assessment results for various diameter pipes. The overall distribution of segments in different condition closely matched the distribution for 8-inch pipes. This is due to the fact that 108 out of the total 136 segments tested in the scope consisted of 8-inch asbestos cement pipe.

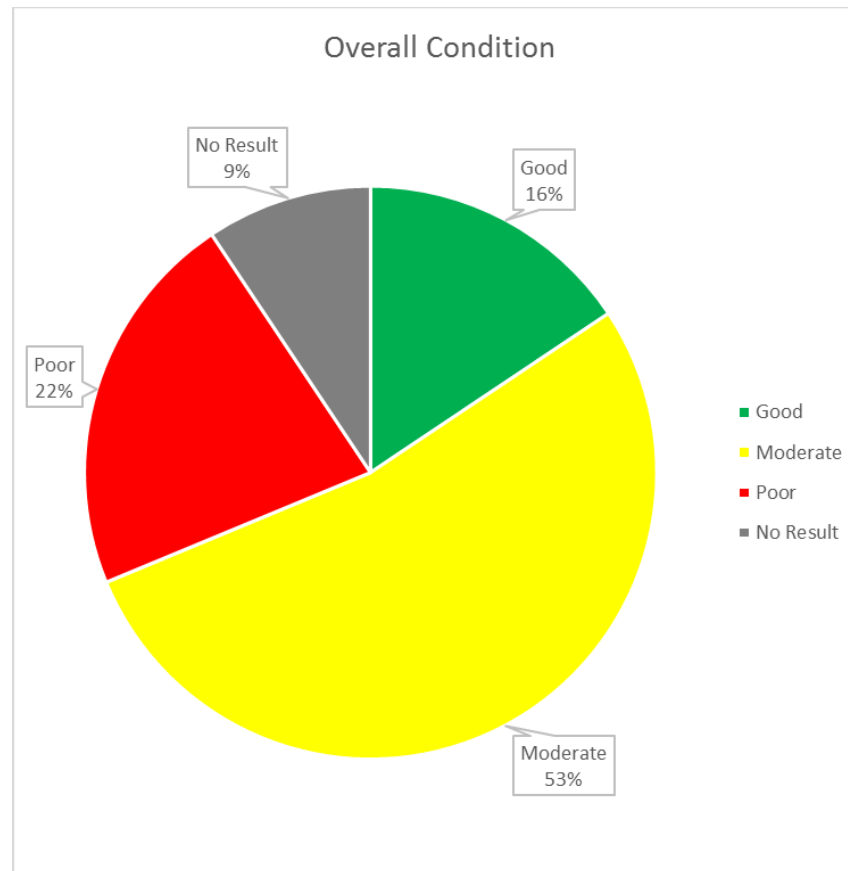
Figure A. 1-3: Overall Condition of Site 1

There were 32 segments tested in Site 1 on [STREET]. This site contained 10,855 feet of 8-inch asbestos cement pipes, the majority of which appeared to be moderate condition.

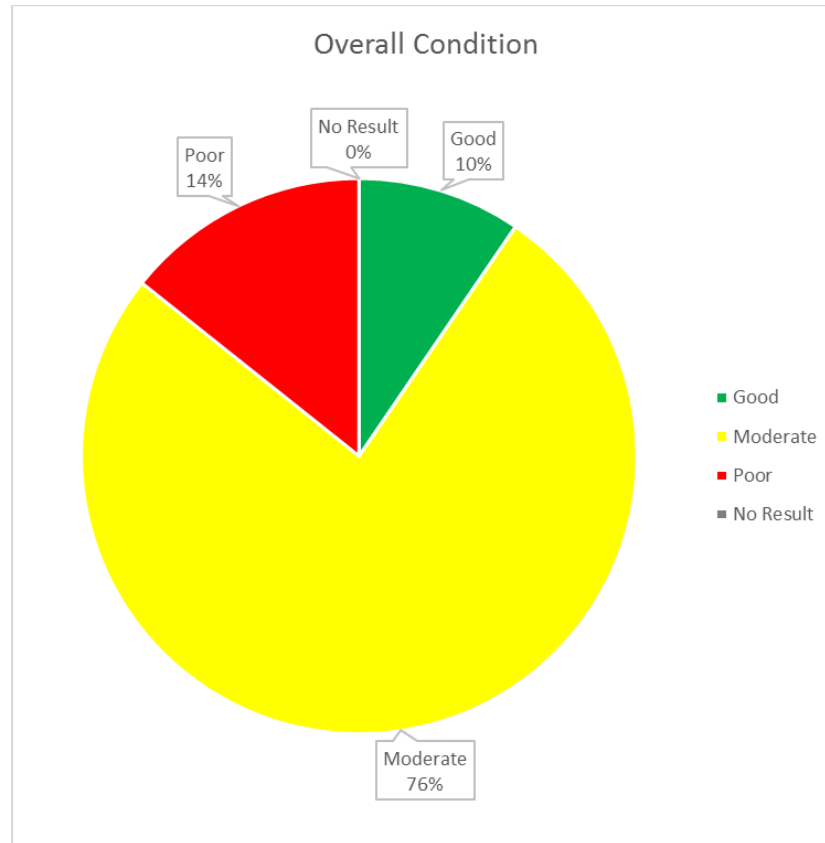
Figure A. 1-5: Overall Condition of Site 2

There were 21 segments tested in Site 2 on STREET. This site contained 7,929 feet of 8-inch, 12-inch and 16-inch asbestos cement pipes, the majority of which appeared to be moderate condition.

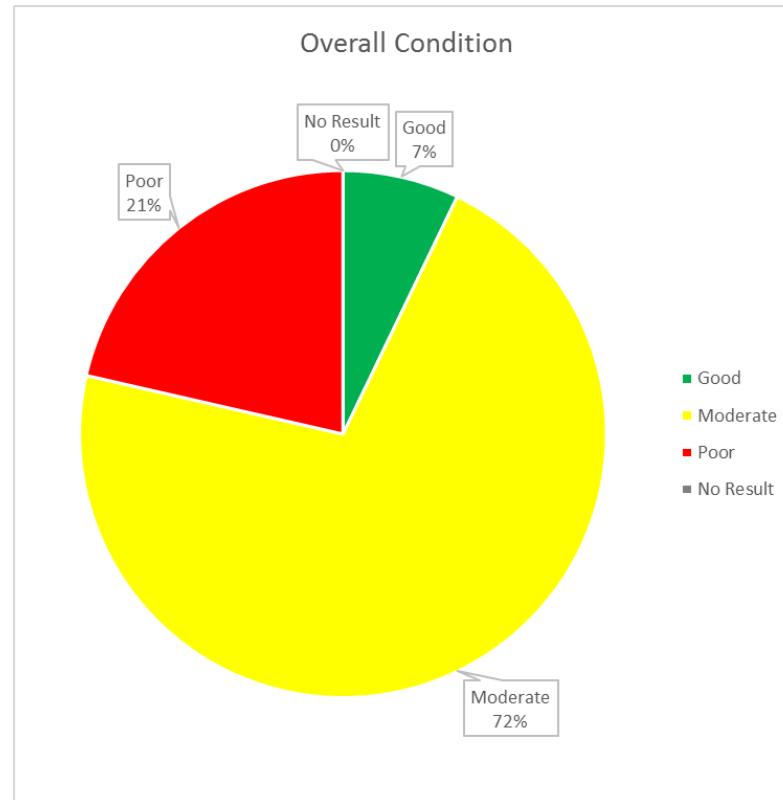
Figure A.1-7: Overall Condition of Site 3

There were 14 segments tested in Site 3 on [STREET]. This site contained 5,202 feet of 8-inch, asbestos cement pipes, the majority of which appeared to be moderate condition.

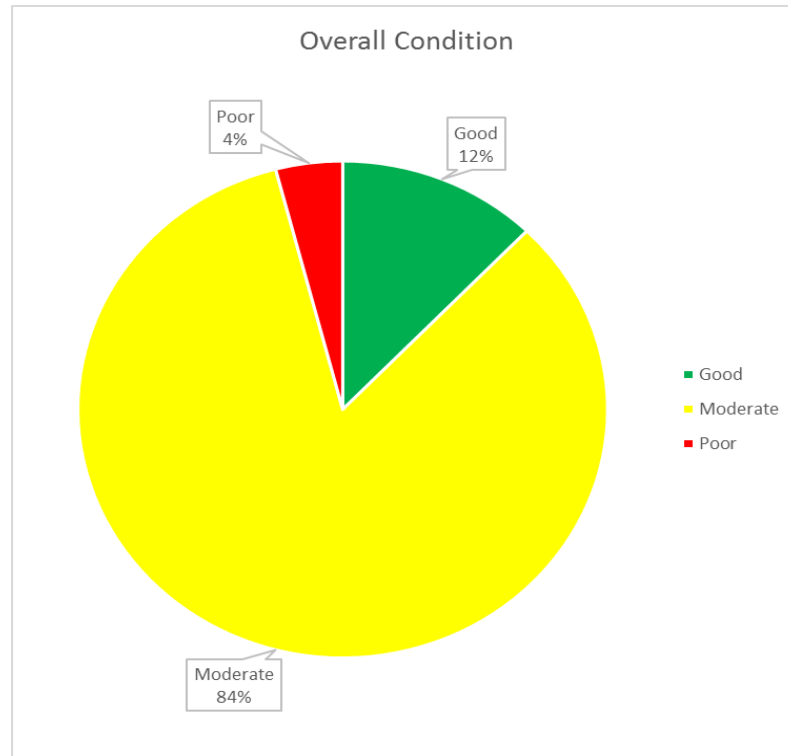
Figure A.1-9: Overall Condition of Site 4

There were 49 segments tested in Site 4. These segments were located on several streets contained 19,919 feet of 8-inch and 12-inch asbestos cement pipes, the majority of which appeared to be moderate condition.

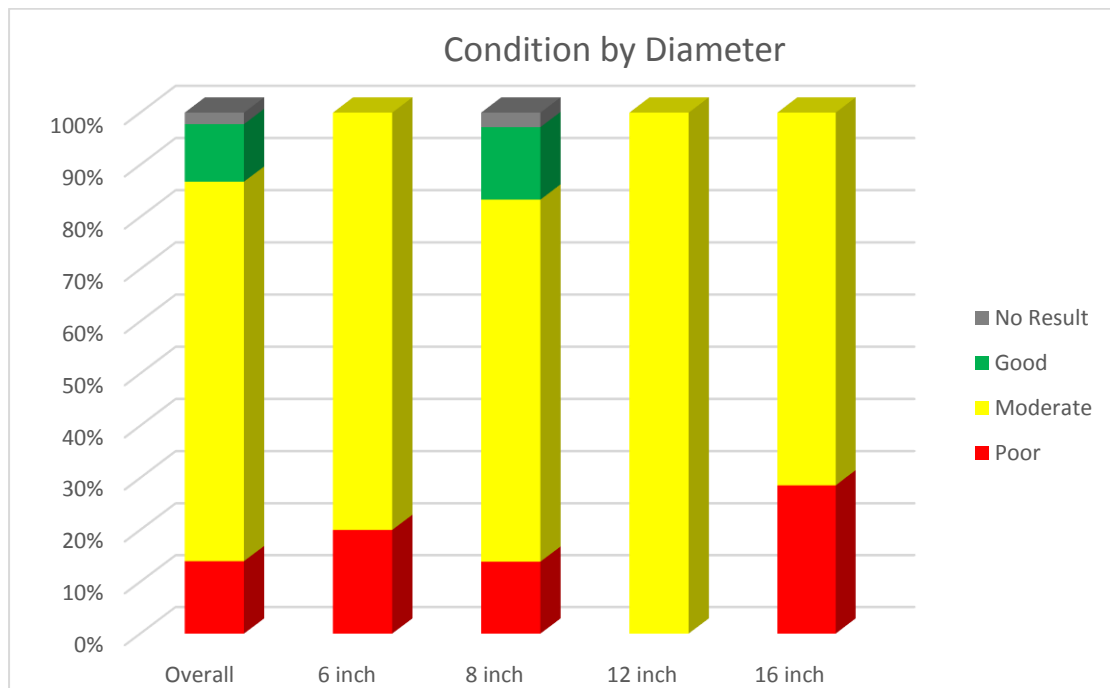
Figure A.1-13: Distribution of Condition for Different Diameter

Figure A. 1-13 shows the distribution of the ePulse® condition assessment results for various diameter pipes. The overall distribution of segments in different condition closely matched the distribution for 8-inch pipes. This is due to the fact that 108 out of the total 136 segments tested in the scope consisted of 8-inch asbestos cement pipe.

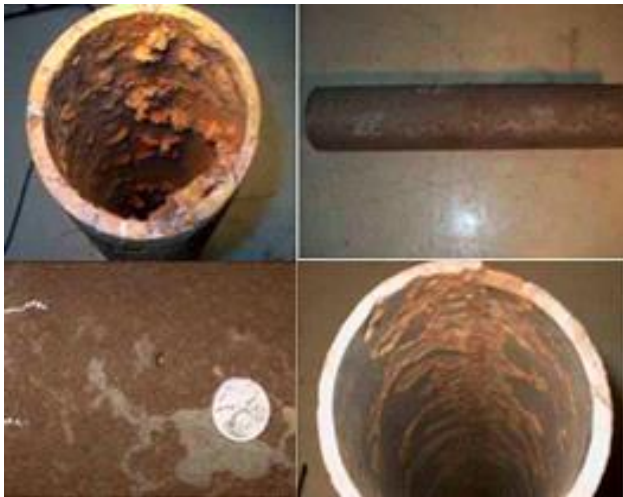
6" Cl pipe with 4.2% measured loss

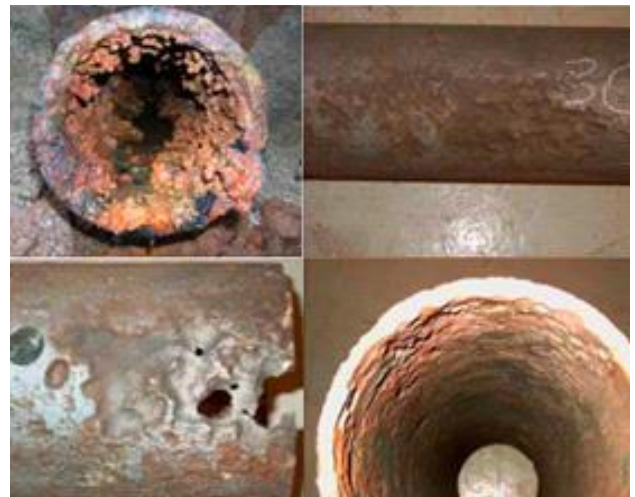
6" Cl pipe with 47% measured loss

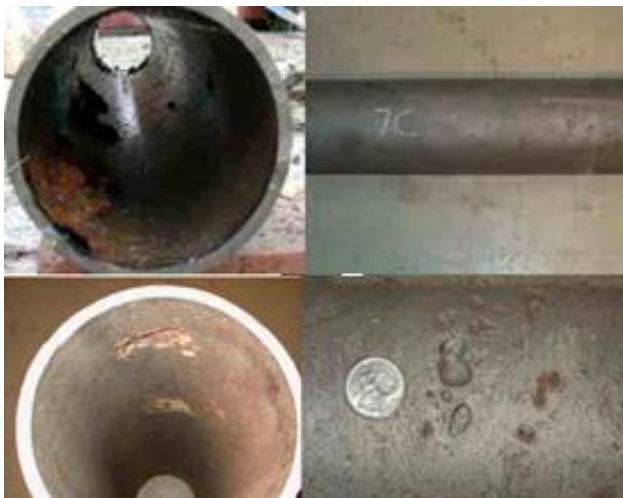
6" Cl pipe with 10% measured loss

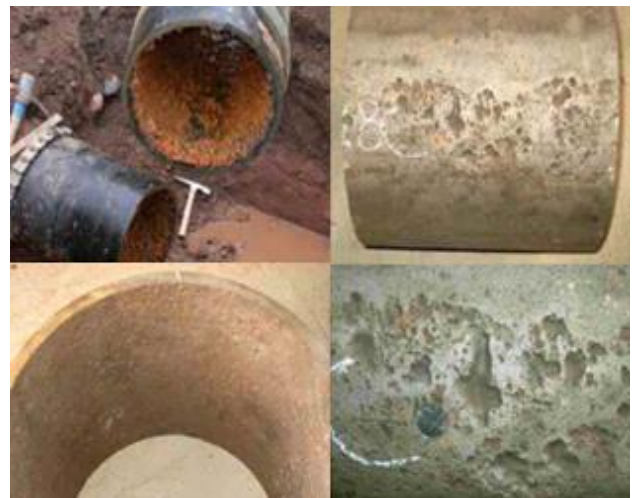
18" Cl pipe with 18.5% measured loss
