Technical **Report**

Title: Condition Assessment and Remaining Service Life
Analysis of Asbestos Cement Water Mains - Phase 4

Client: [CLIENT]

Date: February 3, 2020

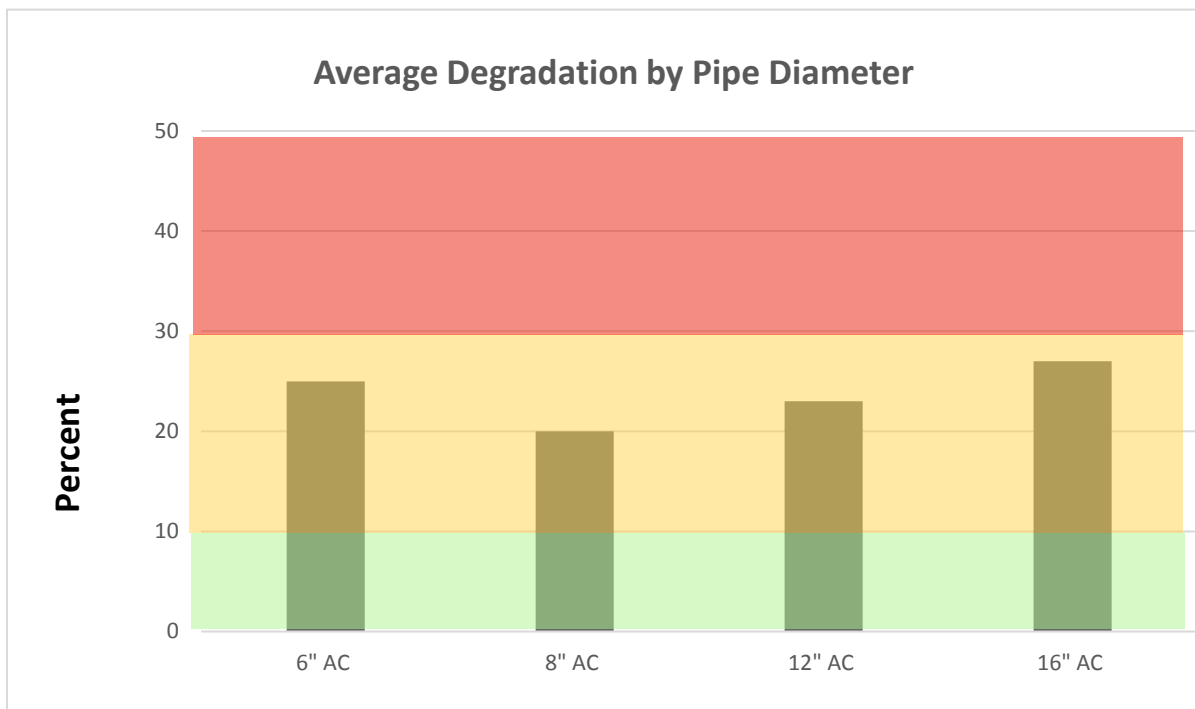
Figure 10: Average Phase 4 Percentage Degradation for All Pipe Diameter

Figure 9 shows the distribution of pipe conditions for different diameter pipes. Figure 10 shows average phase 4 percentage degradation for all pipe diameter.

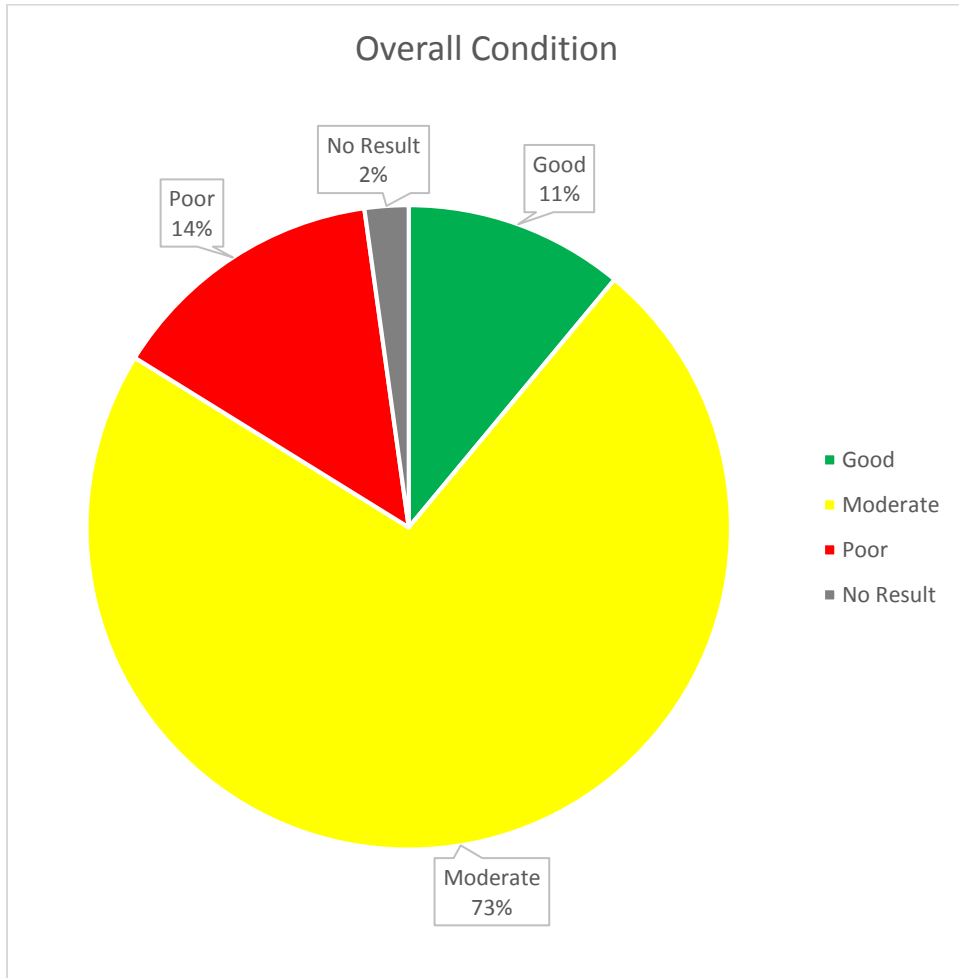
Figure A. 1-2: Overall Condition of Scope by Segment (%)

Figure A. 1-2 shows the results breakdown by condition category for the entire project scope.

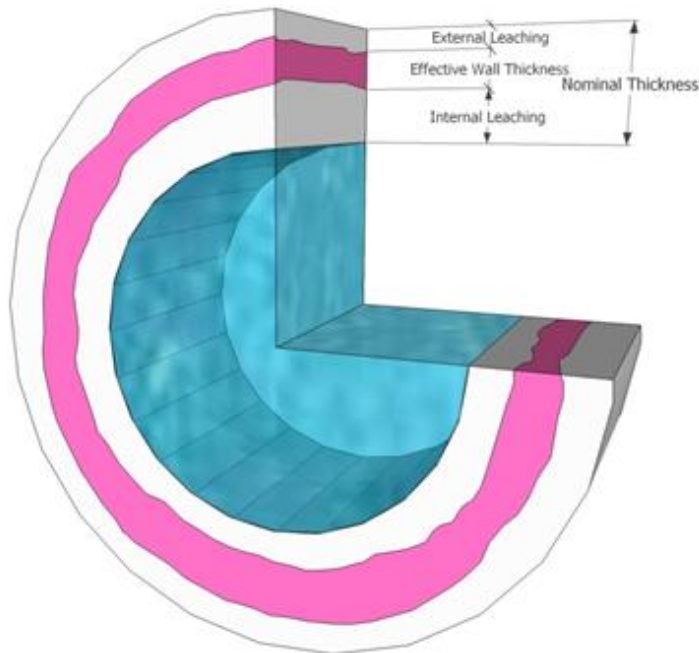
Figure B.2-1: Structural Hoop Thickness in Asbestos Cement Pipe

As asbestos cement pipes age and degrade, they will not lose physical thickness, but will lose structural (or effective) thickness as the calcium leaches out of the asbestos cement matrix. This portion of the asbestos cement will become soft, and will no longer bear a structural load, and therefore does not contribute to the structural thickness. The ePulse® method measures the remaining structural hoop thickness (also known as the effective hoop thickness), as illustrated in Figure B.2-1, rather than the actual physical hoop thickness (which will generally remain at the nominal hoop thickness).

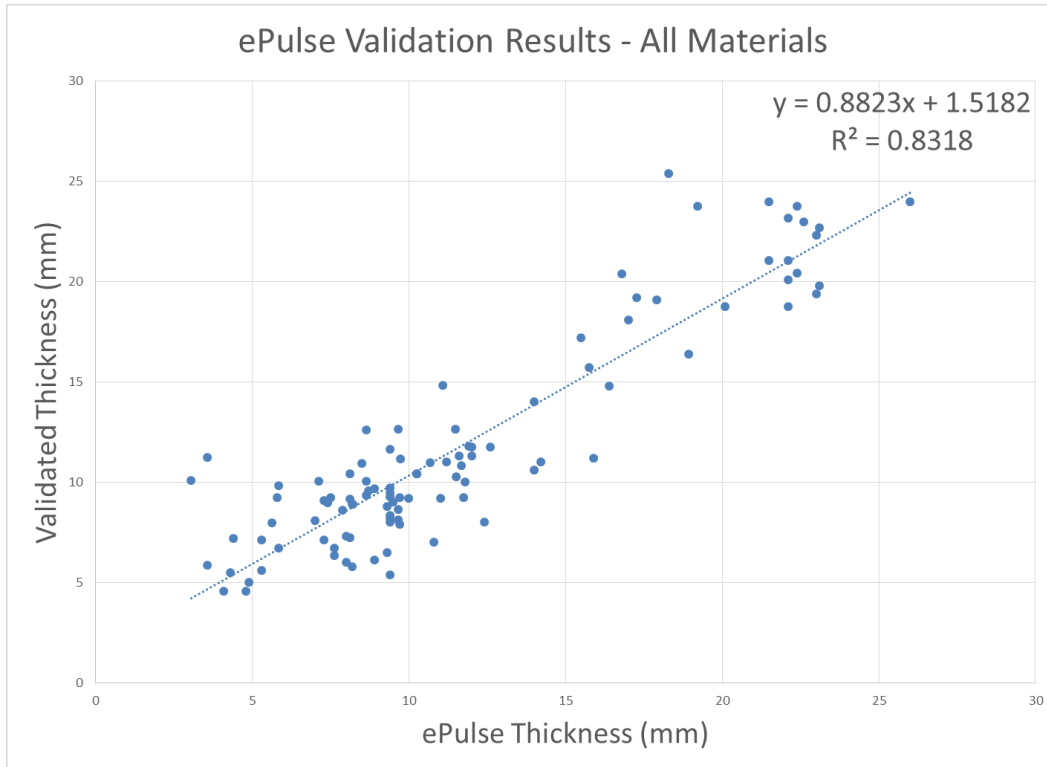
Figure B.2-3: ePulse® Validations On All Materials

As of the February 2016, a total of 104 ePulse® validation results have been provided to Echologics by our clients or third parties. Some clients have requested confidentiality, however we are able to present the result in aggregate.

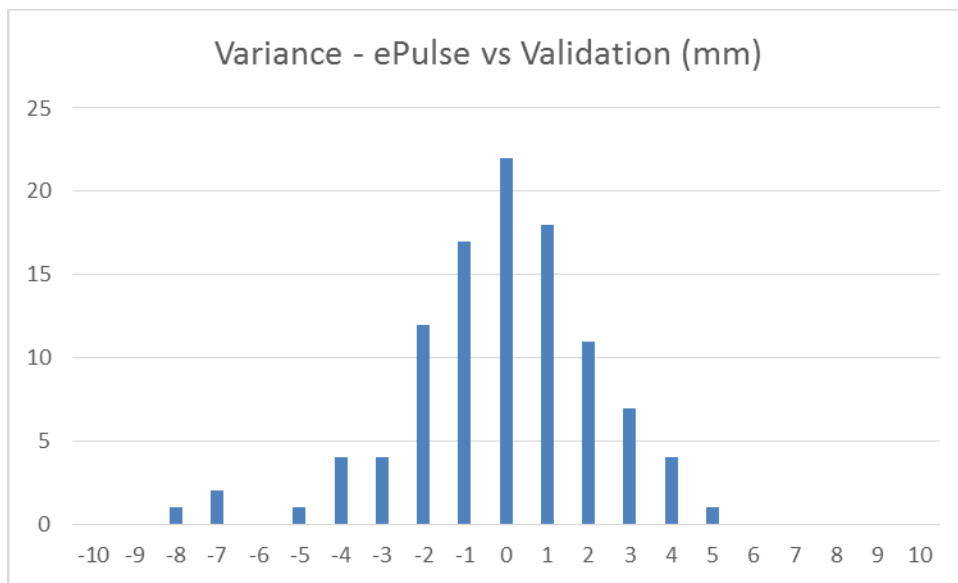
Figure B.2-5: Variance between ePulse® results and validation results

Actual pipe conditions will vary randomly along the sample, so the difference between the true average and validation results should be a normal distribution centered around zero. If ePulse[®] is effectively measuring the true average, we should see the same pattern in the difference between

the ePulse® and Validated results. The actual distribution is shown in Figure 3, and appears to match the expected pattern.

There are a small number of outliers, which likely represent errors in those ePulse® measurements. The remainder of the data match the expected normal distribution.
